SERVICE BULLETIN

TS-940S PLL UNLOCK

4-8-86

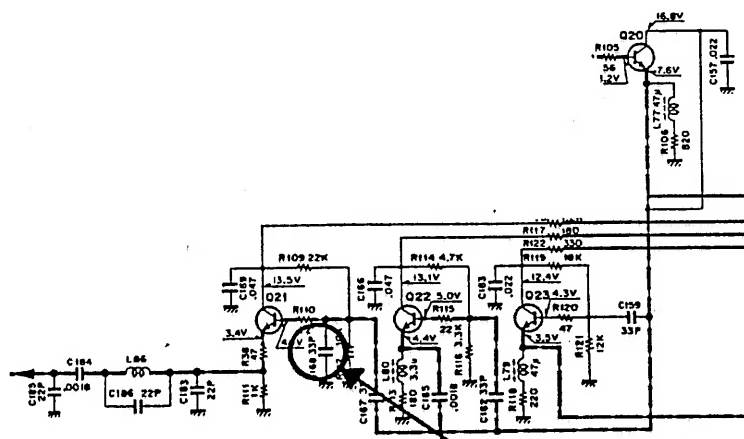
Reports of a PLL Unlock on the lower frequencies may be due to low VCO levels. The following change will increase the VCO level and should prevent reoccurrence of this symptom.

1. On the RF Unit (X44-1660-00) change C168 from a 33 pF capacitor to a 15 pF 50 v capacitor.
2. Readjust the VCO BPF (RF unit L74-76) according to the instructions contained in the TS-940S service manual.

Change C168 from 33 pF to 15 pF
